# Conservation Plan

For the campus of:  
**Middle Tennessee State University**

## **Conservation Plan for MTSU**

### **ABAS 4370 Soil and Water Conservation**

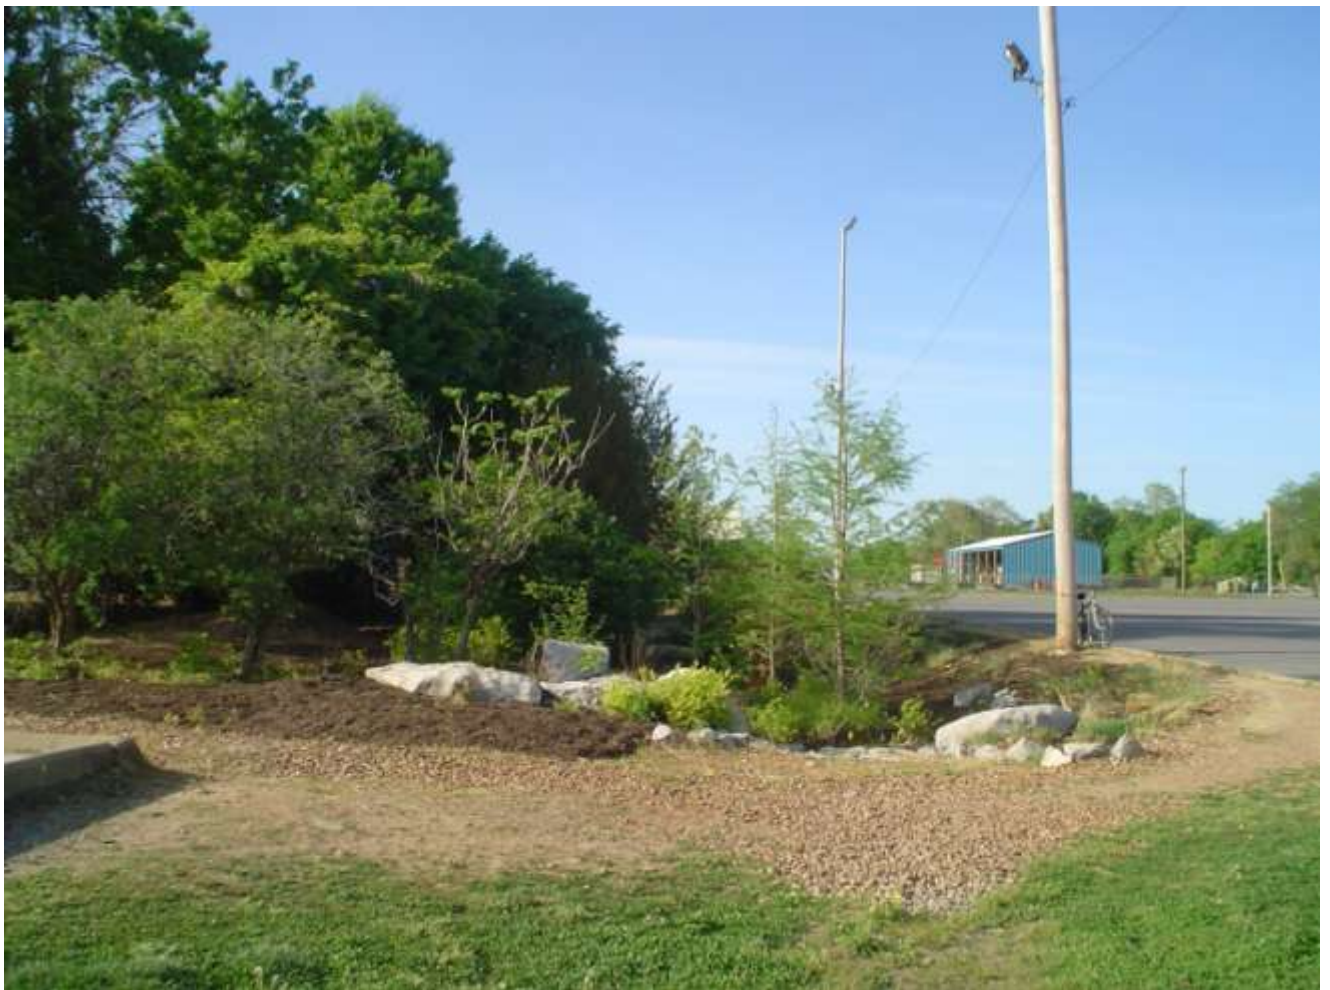
Figure 1 Raingarden Number 1 Post Annual Maintenance

The photos above were taken during the remediation of Raingarden Number 1. Work was performed by class members of ABAS 4370 during the Spring 2010 Semester with the oversight of Dr. Anderson and Mr. Larry of the MTSU Greenhouse staff. Work included: weeding, raking, redistribution of current rock bed, and the installation of new organic mulch.

- Performed annual maintenance: weeding, installed new organic mulch, and smoothed rock bedding

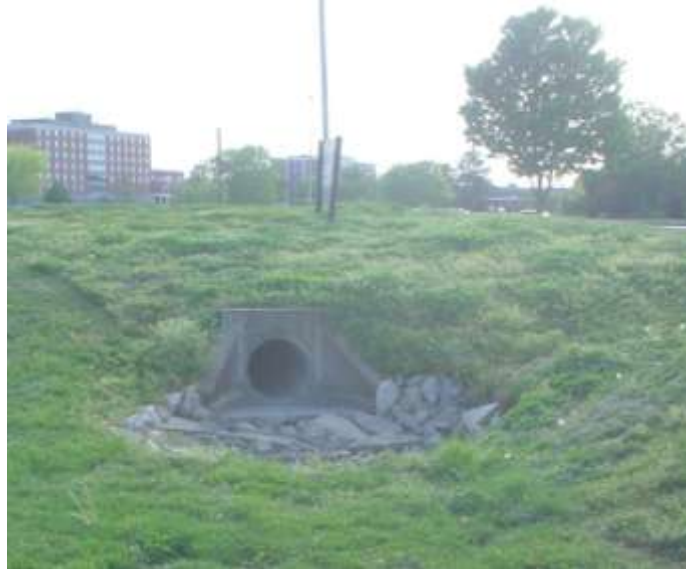
Figure 2 Culvert Pre-remediation

- Installed four plunge pools: two on the northwest side of Scarlett Commons and two on the southeast side

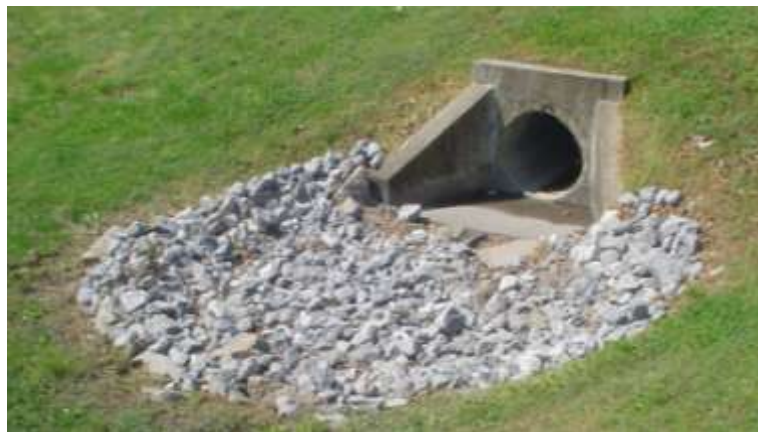
Figure 3 Culvert Post-remediation

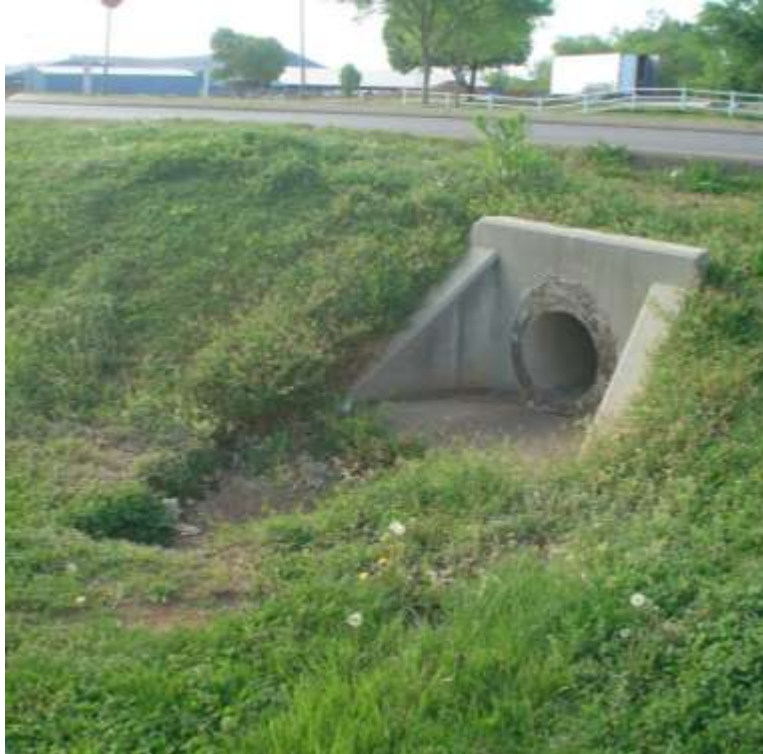
Figure 4 Culvert Pre-remediation

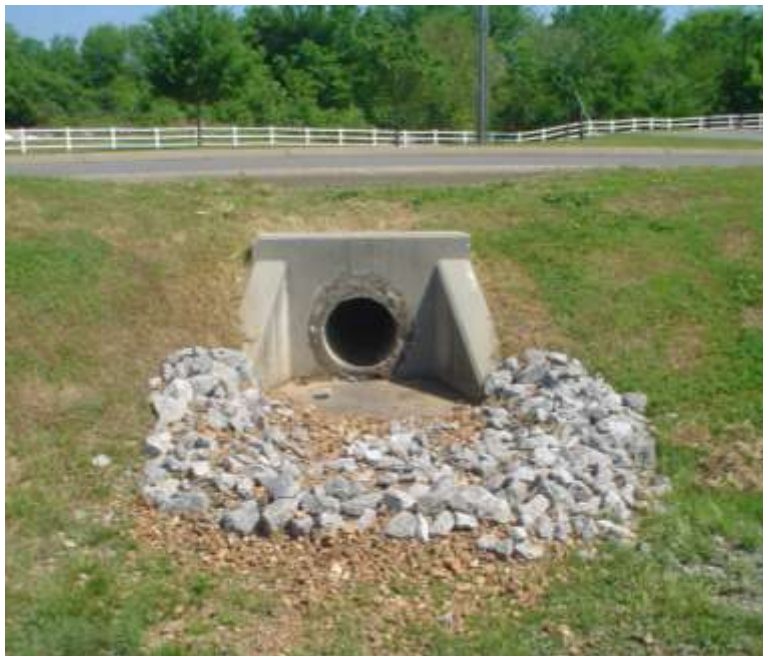
Figure 5 Culvert Post-remediation

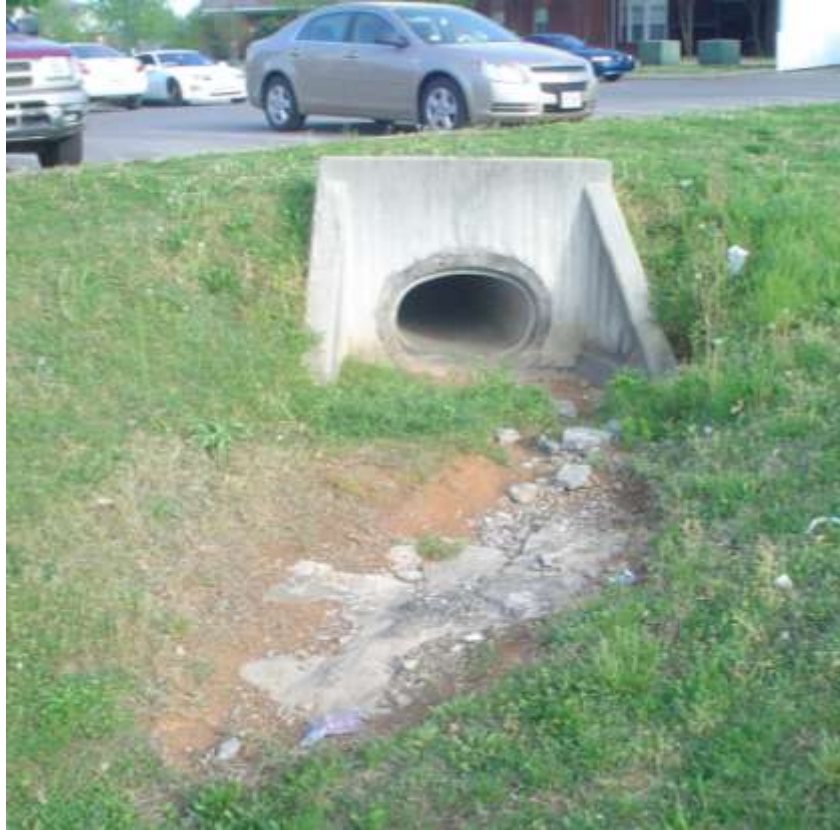
Figure 6 Inlet From Northwest Site to Southeast Site Pre-remediation

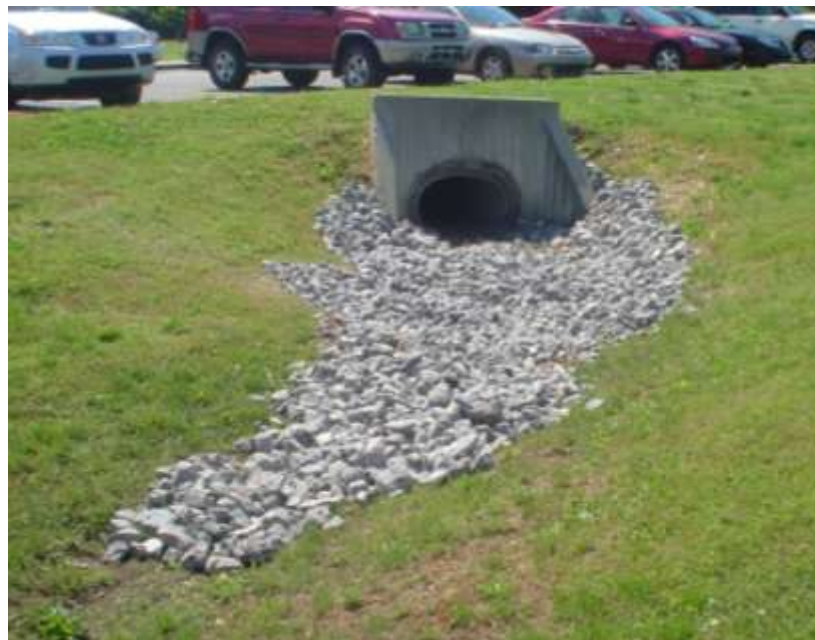
Figure 7 Same Site as Figure 8 Post-remediation

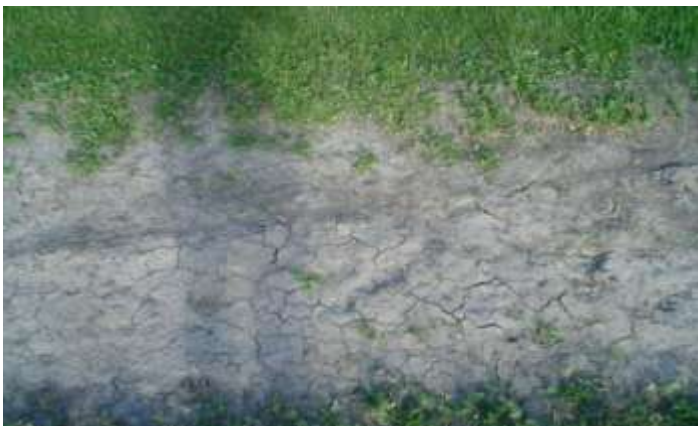
**Figure 6:** Calcium Carbonate which has precipitated onto a rock from runoff on campus.

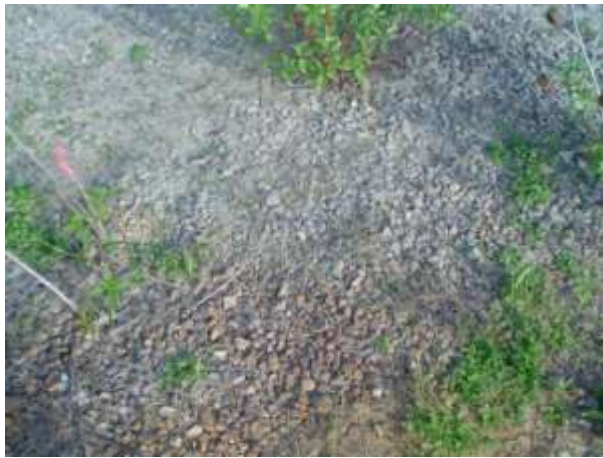
**Figure 13:** This figure demonstrates the affects of runoff on the gravel in Raingarden #2.

In figures 13 and 14, the grey colors demonstrate a buildup of Calcium Carbonate, while the brown shows the original color of the river rock used in the Raingarden.

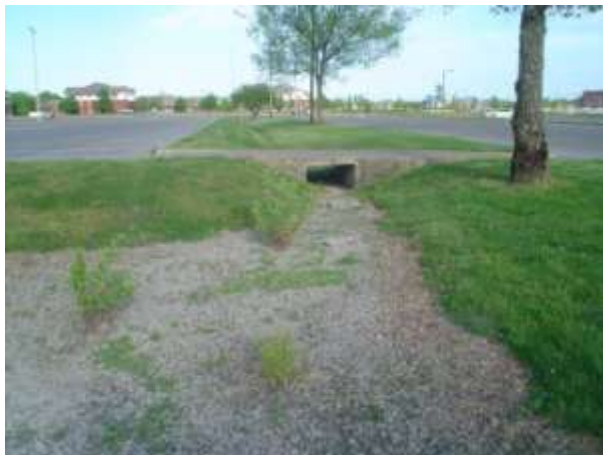
**Figure 14:** This site shows Raingarden #2 from a due east direction.

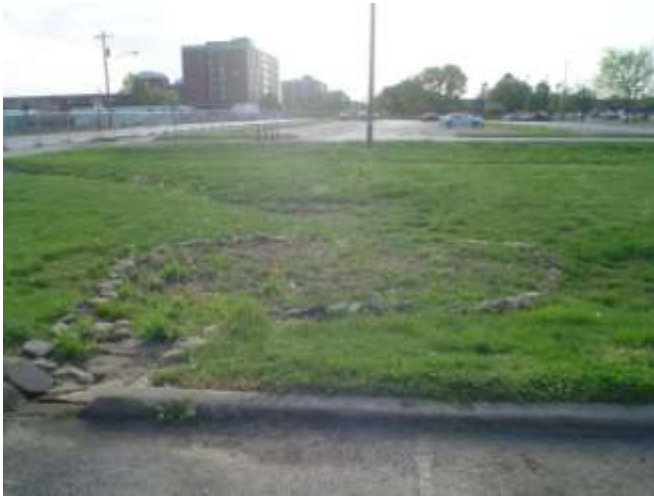
**Figure 22:** The inlet and Raingarden #3.

Figures 22, 23, and 24 demonstrate Raingarden #3 on MTSU's campus. From these photos, it is obvious that Raingarden #3 needs remediation because it is the only drainage spot for the large parking lot around it.

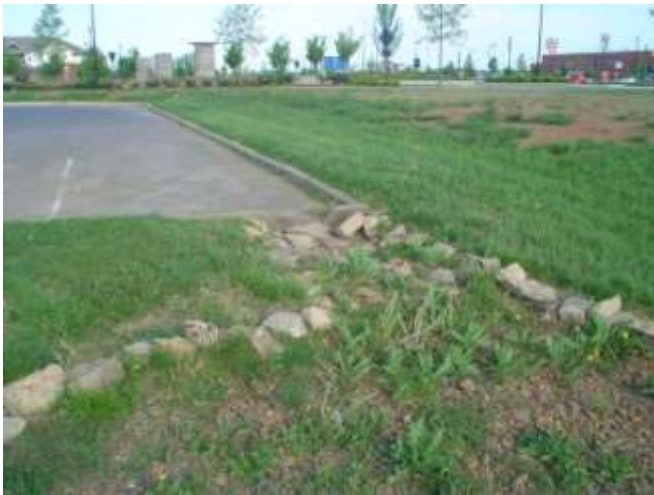
**Figure 23:** The inlet of Raingarden 3#.

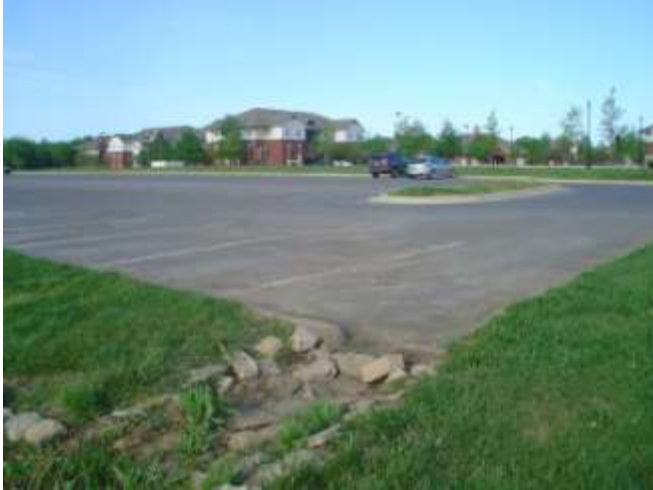
**Figure 24:** The inlet of Raingarden #3.

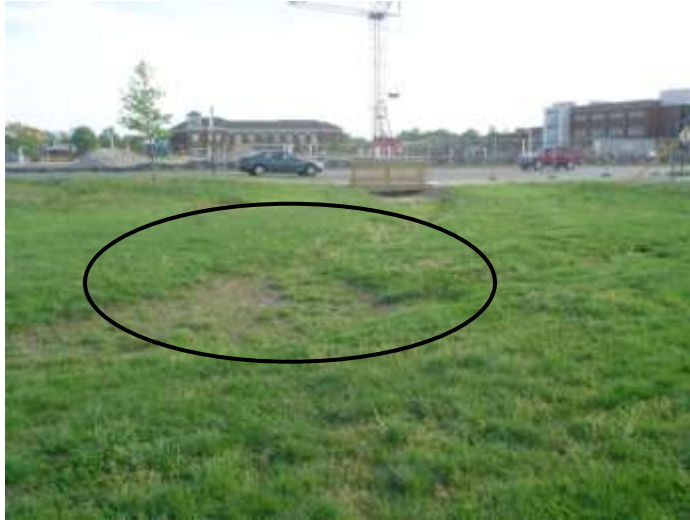
**Figure 26:** This photo was taken against the flow of runoff to Raingarden #3. This circle in this figure shows a proposed site for filter strips on campus.

Around this area, there is only one 300 square foot Raingarden. The filter strips would be a useful addition because this small Raingarden is not sufficient enough for the large area which it encompasses.

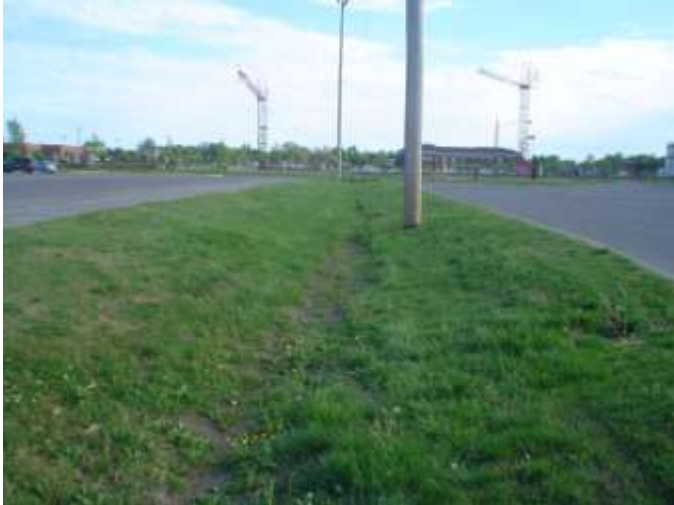
**Figure 29:** This is facing against the flow towards Raingarden #4.

Figures 29 and 30 demonstrate the only two outlets in this area which includes about 4 acres of parking lots.

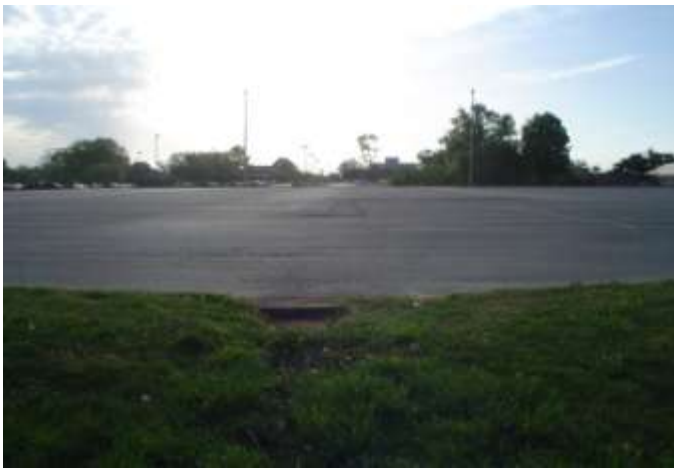
**Figure 30:** This is also facing against the flow to Raingarden #4.

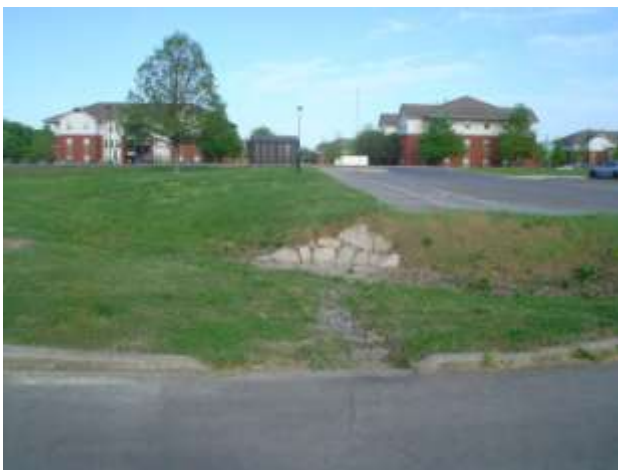
**Figure 31:** This shows the same area as figures as 29 and 30, yet this is on the other side of the inlet. The work done here was mostly for erosion control.

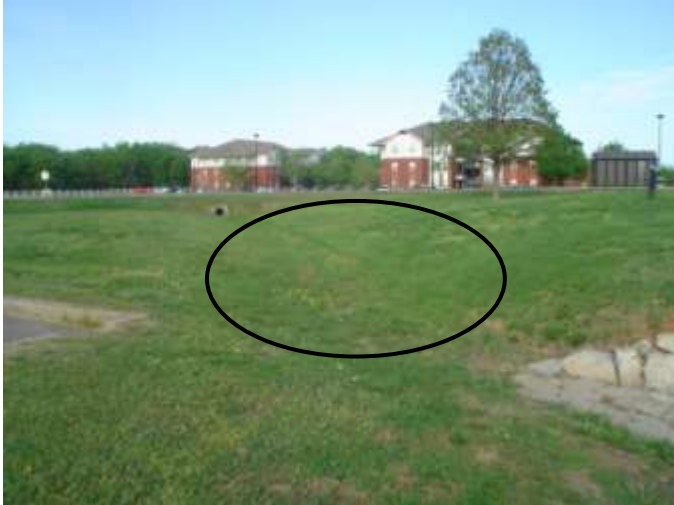
**Figure 32:** This area in the circle shows a proposed site for filter strips.

The filter strips that are mentioned in figures 32, 33, and 34 are needed because all the runoff from about 7 acres of parking lots and surrounding areas ends up here.

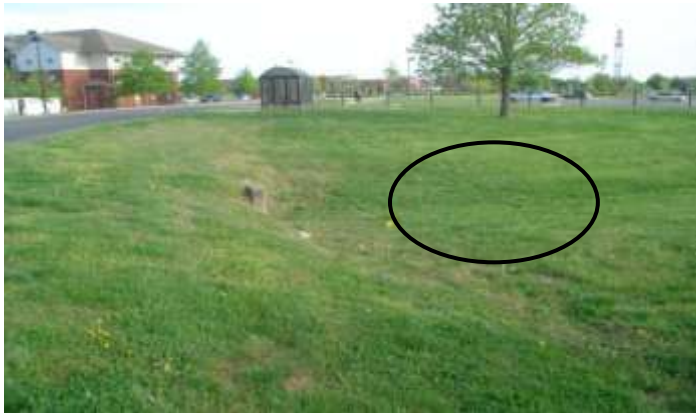
**Figure 33:** This is a close-up view of the area for the proposed filter strips.

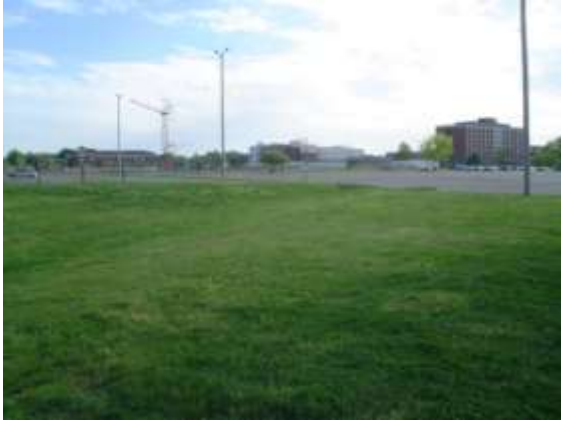
**Figure 34:** This is the same area for the proposed filter strips, but this photo is from the other direction.
